WATERWORKS SYSTEM ASSESSMENT FOR THE TOWN OF WILKIE

**TOWN OF WILKIE
WATERWORKS SYSTEM ASSESSMENT**

The Town of Wilkie is a community with a population of approximately 1,301, located approximately 60 kilometers southwest of the City of North Battleford along Highway 14. Bullée Consulting conducted a site inspection on November 27th, 2015.

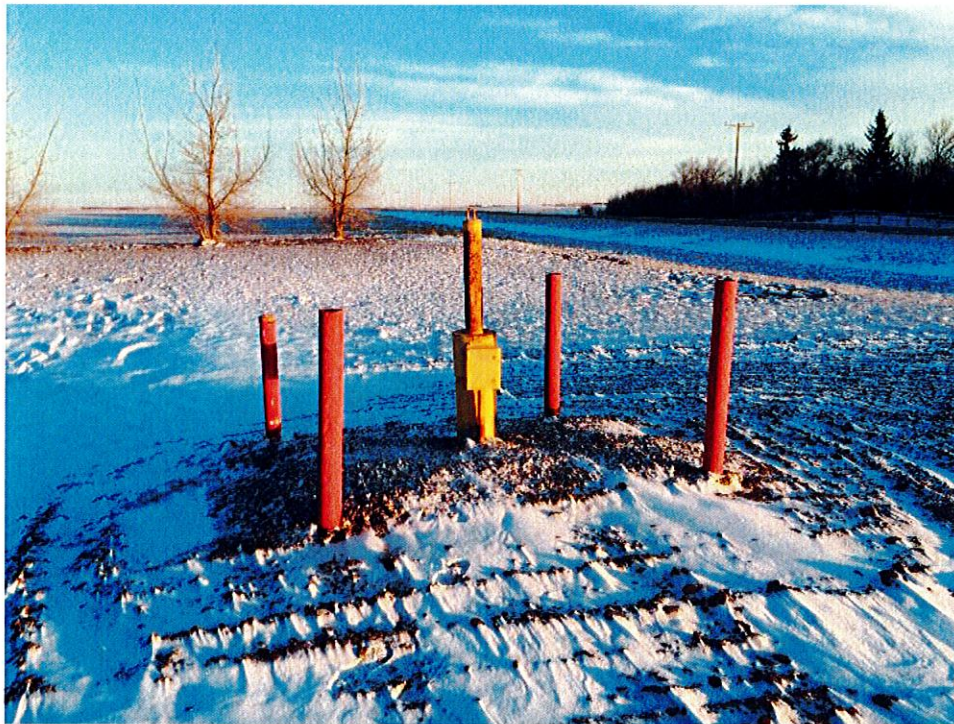
Well #3 is located on section SE 1-Twp 40-Rge 20-W3. The pitless adaptor and 30 horsepower (hp) submersible pump are located approximately 15 metres (m) from the metal clad building which houses the electrical components and unit heater. Since the previous Waterworks System Assessment (2011), well #3 has received a new pump and motor. The interior of the building, metal piping and controls are in fair condition. The well driller's report indicates that the well was constructed in 1998 and is approximately 36.6 m (120 ft.) deep. The water audit report completed in 2002 by Pinter and Associates indicated that the well has a typical flow rate of 15.9 litres per second (L/s) or 210 imperial gallons per minute (lgpm).

Well #3 Well Head

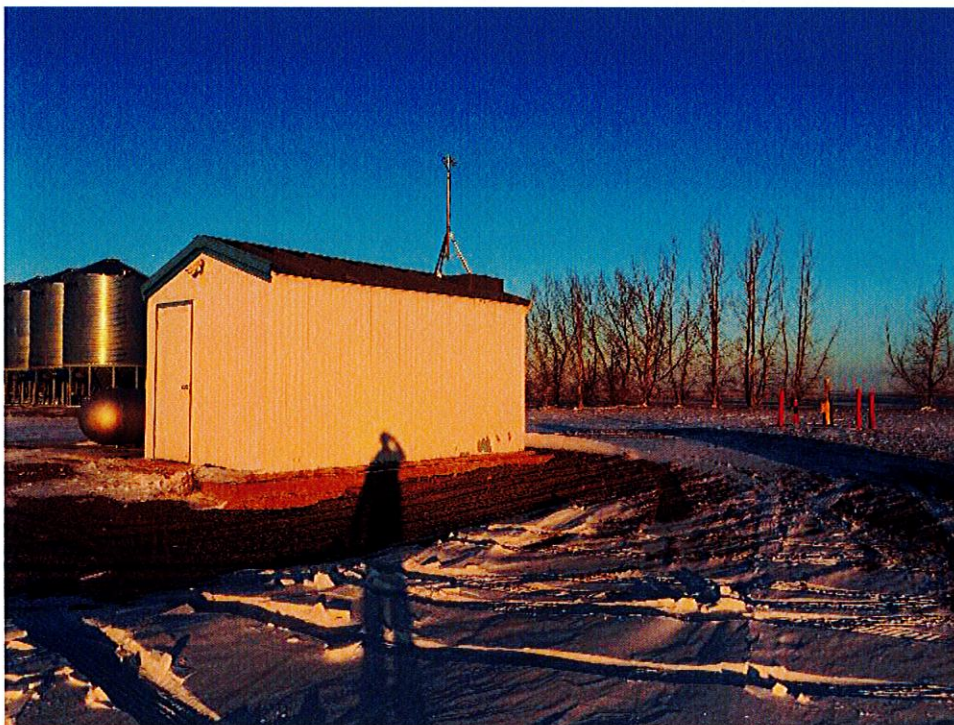
Well #3 Controls Housing

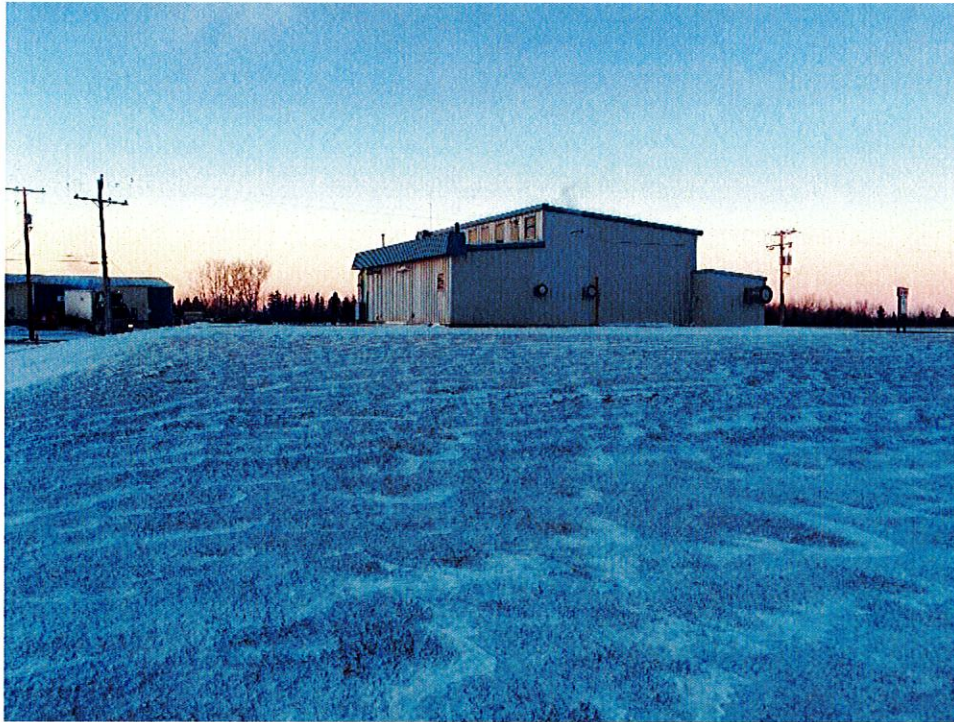
The underground concrete chambers were constructed at the time of the water treatment plant construction in 1983. The two chambers are connected by a 300 mm (12") diameter valved transfer pipe. Treated water can be discharged from the filter unit into either reservoir. Similarly, distribution pumping can be drawn from either reservoir. Additional storage is provided by the water tower, which is connected by the distribution network.

Water Treatment Plant Building, Underground Reservoir in Foreground

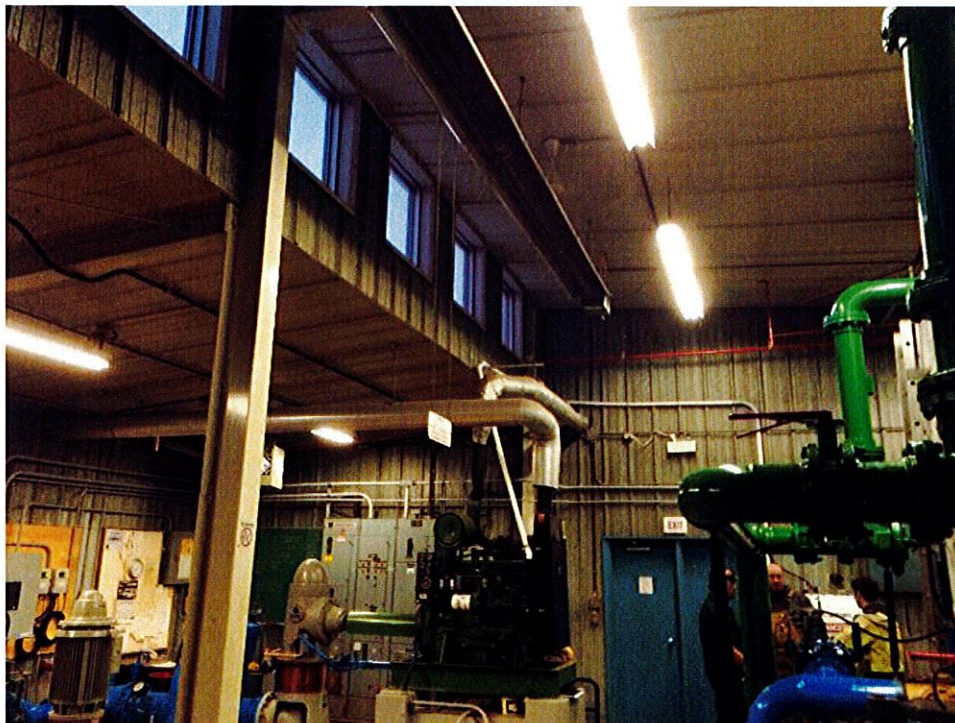
The building is heated by a natural gas unit heater, as well as a radiant heater. Fluorescent lights and natural light from windows light the building well. Space in the building is adequate, with ample room for chemical storage, maintenance and lab testing space. The mechanical piping in the facility is in good condition.

Plant Interior

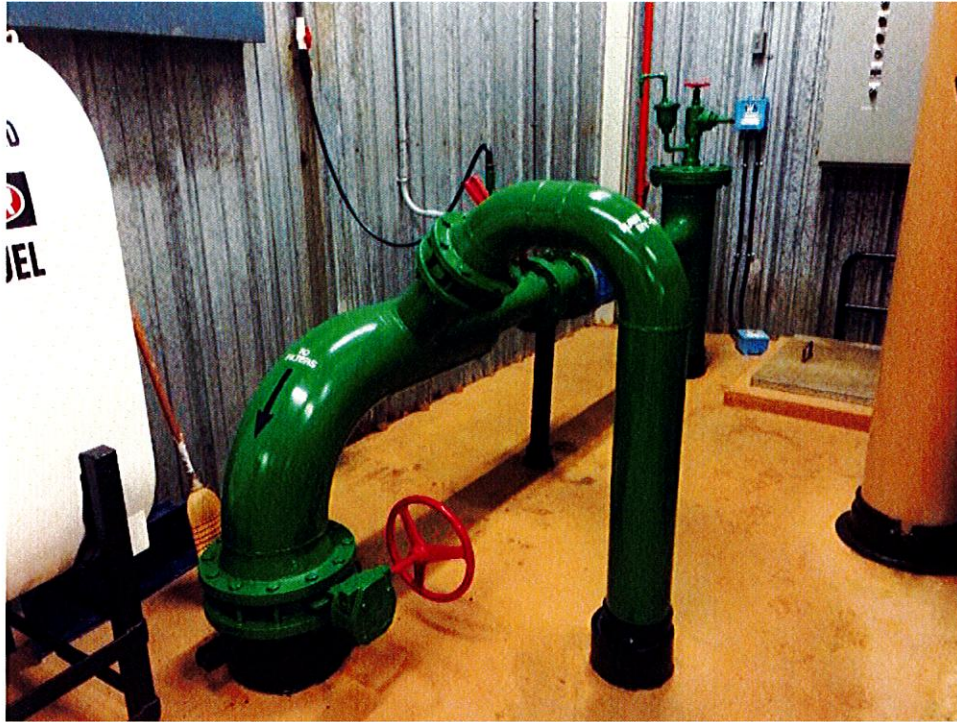
The potassium permanganate chemical feed pump is a Grundfos DDI pump in good condition, rated at 720 litres per day (Lpd) (158 lgpd). The potassium permanganate is injected into the raw water piping as it enters the water treatment plant. Potassium permanganate is used to begin the oxidization of iron and manganese. The operator feeds potassium at an approximate feed rate of 3.1 mg/L. The iron and manganese concentration of the raw water requires a feed rate of approximately 2.8 mg/L but does not account for other particles in the water which may also interact with potassium permanganate. Therefore the feed rate of 3.1 mg/L appears to be in the proper range. The maximum use limit for potassium permanganate is 50 mg/L, with the typical use limit approximately 15 mg/L.

Raw Water Influent Piping

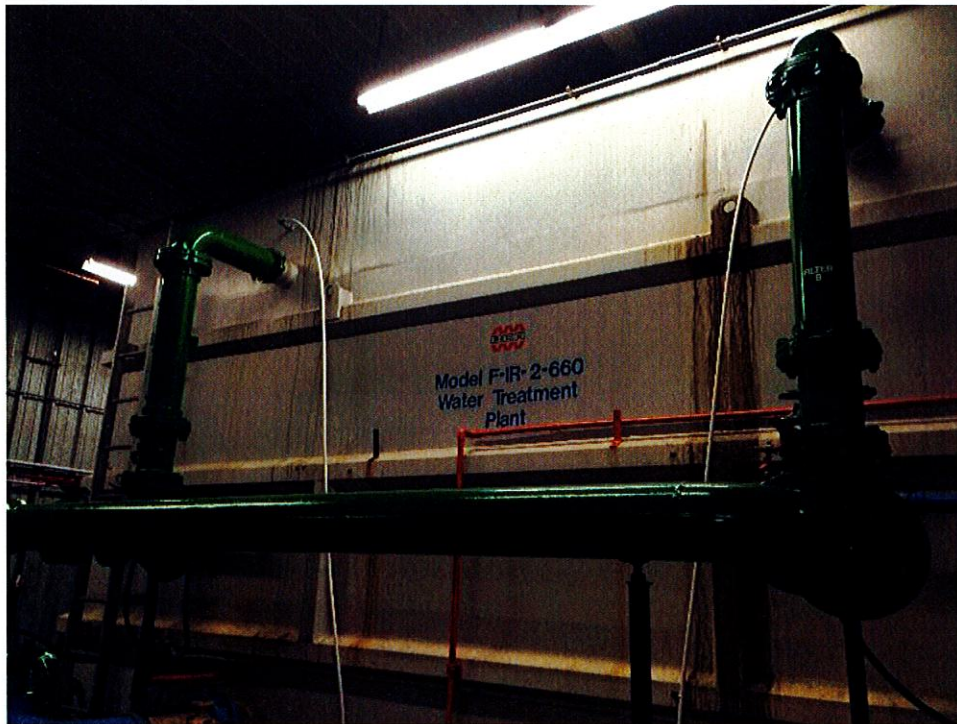
The filter unit in the water treatment plant was installed in 1985 and is a BCA model F-IR-2-660. There are two halves to the filter unit (A and B). The media in the filter unit is manganese greensand, which is typical for iron and manganese removal. The operation and maintenance manual indicates that there is a total detention time of 22.6 minutes provided by the filter tanks. It also indicates that each filter half is capable of filtering at a rate of 20.8 L/s (330 USgpm), for a total filtration rate of 41.6 L/s (660 USgpm). The filters are set up to backwash based on the pressure differential across each filter, however, the operator initiates the process manually, as the filter units are not connected to the programmable logic controller (PLC). Typically the filters are each backwashed once per day. Aeration is not used in the backwash process. Each filter is backwashed for approximately 7 minutes at a rate of approximately 69.4 L/s (1,100 USgpm). The wastewater flows into the backwash water chamber and then via a pipe to the gravity sewer system. Filter to waste piping is installed to prevent turbidity issues immediately following backwash, once filters are put back into operation.

Manganese Greensand Gravity Filter Unit

Presently, aeration is not used in the backwash process. An air scour system would improve the effectiveness of the backwash process and decrease water consumption.

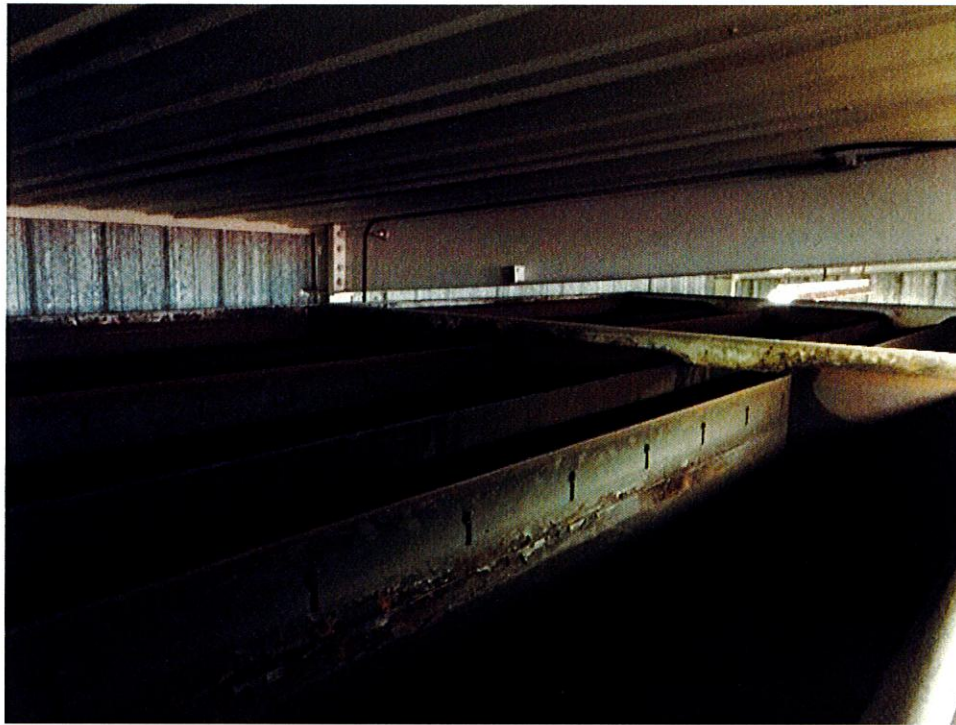
Static mixers were recently added to the influent piping on both sides of the filter unit in an effort to increase oxidization effectiveness. Replacement valves for the filter effluent lines have been purchased and are to be installed shortly. The valves on the influent piping are also intended to be replaced in the near future.

Manganese Greensand Gravity Filter Unit

It is recommended that the Town have the filter unit connected to and controlled by the new PLC for improved control and monitoring purposes. The cost to complete this is approximately \$45,000.

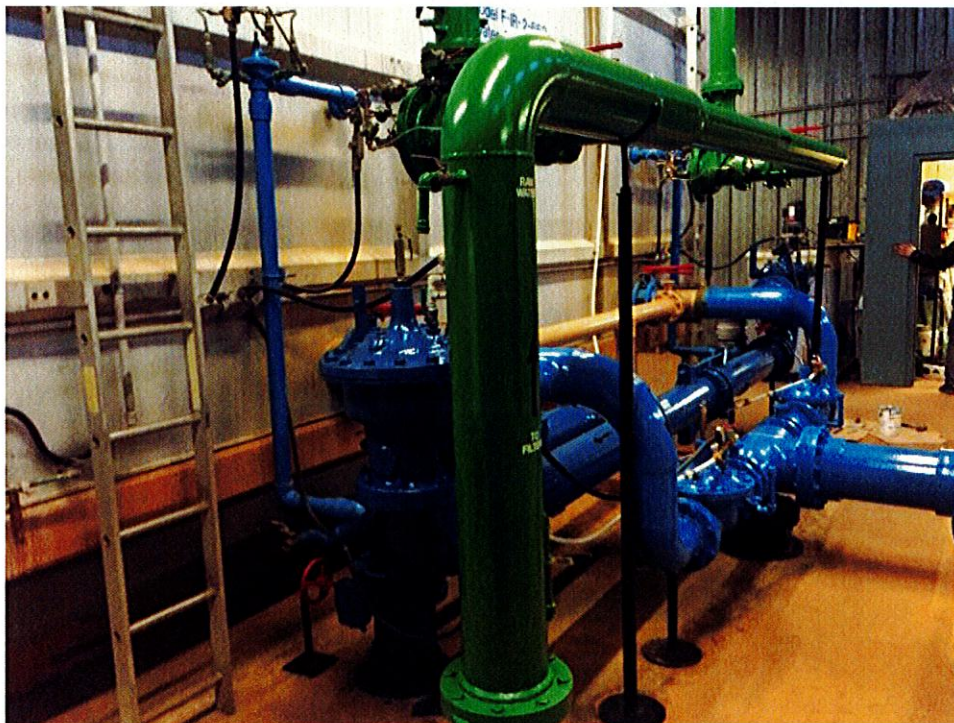
Filter Process Piping

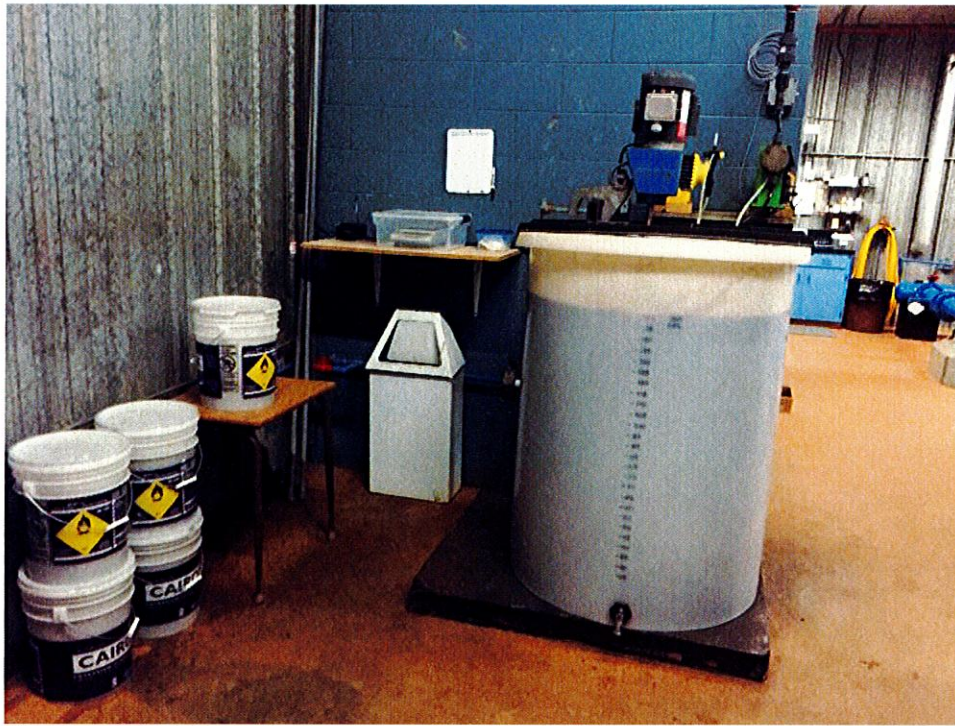
The potassium permanganate chemical feed pump is activated based on the well start / stop condition. This could lead to a possible overfeeding of potassium permanganate if the well fails to supply water to the water treatment plant as chemical feed pumps will continue to operate.

KMnO₄ Feed Station

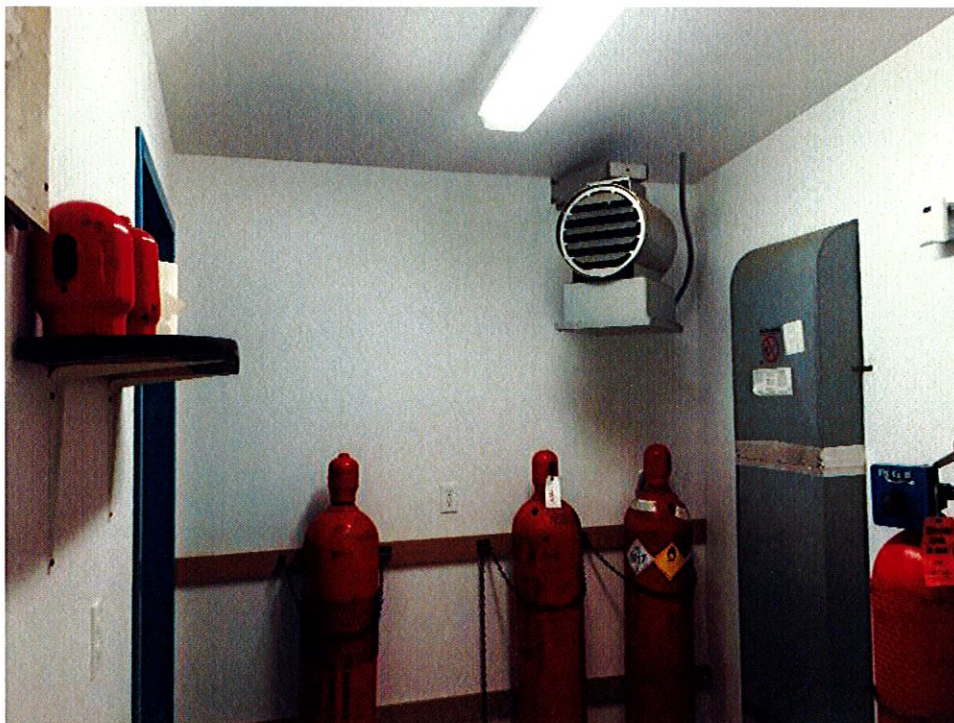
Chlorine gas is fed into the water prior to entering the treated water reservoir. There is an automatic switch between gas cylinders once a cylinder is emptied. A gas detection alarm is also present and sends an alarm to the main PLC if a gas leak is detected. An autodialler telephones the operator's cell phone to notify him of the alarm. The plant has a separate chlorine room with its own ventilation system and exterior access to house the chlorine gas cylinders. Chlorine gas is fed at a concentration of approximately 3.1 mg/L, which is below the typical use limit and maximum use limit of 10 mg/L and 30 mg/L, respectively.

Separated Chemical Room

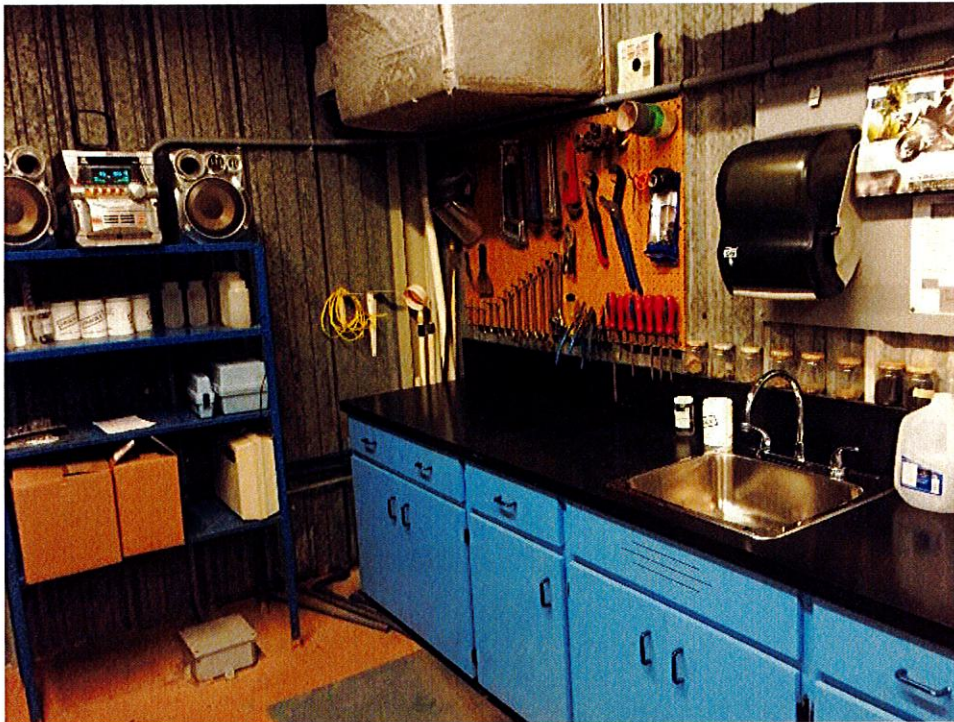
The water quality testing is completed daily using the Hach DR 890 Colorimeter and 2100P portable testing units. The DR 890 colorimeter and 2100P turbidimeter are in good condition. The Operator reported that the daily testing practice was to test for free and total chlorine levels, iron and manganese concentrations, and turbidity of the treated water.

Workspace and Testing Area

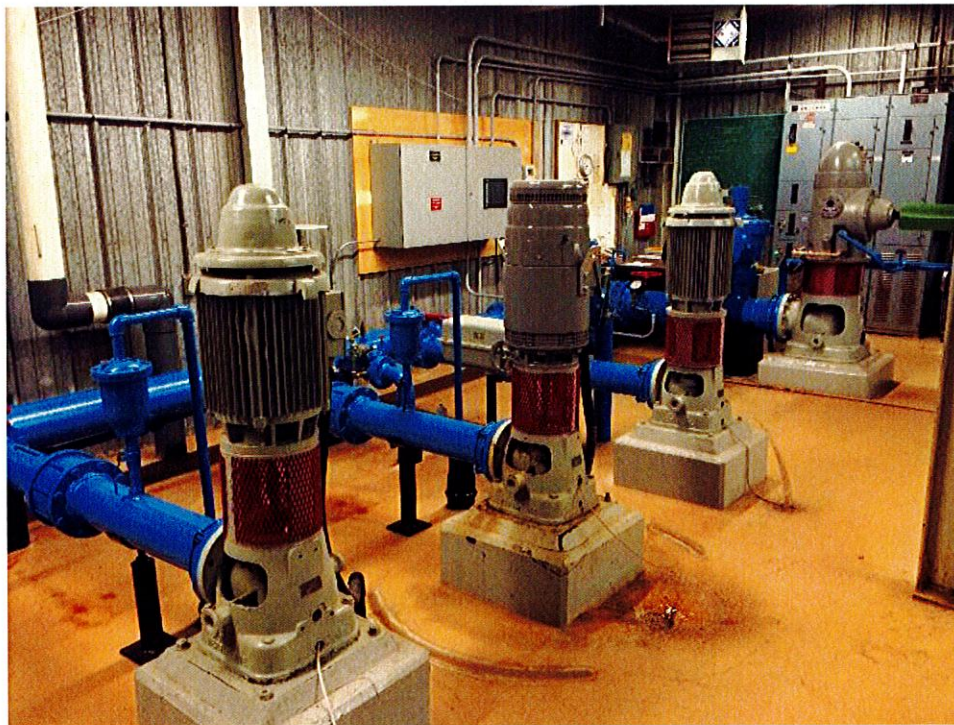
Distribution pumps #1 and #2 are Aurora Vertiline type 7RH, 15 hp, 1770 rpm, 8 stage, 3 phase pumps, each capable of pumping 20.8 L/s (330 USgpm) at 35.1 m (115 ft.) TDH. Pump #2 was replaced in 2014. Distribution pump #3 is an Aurora Vertiline 30 hp, 1770 rpm, 2 stage, 3 phase pump rated at 44.2 L/s (700 USgpm) at 35.1 m (115 ft.) TDH.

Distribution Pumps and Header

The distribution pumps are currently operational, but aging, as indicated by the recent replacement of pump #2. It is recommended that the Town budget for the replacement of the remaining pumps in the near future at a cost of approximately \$20,000.

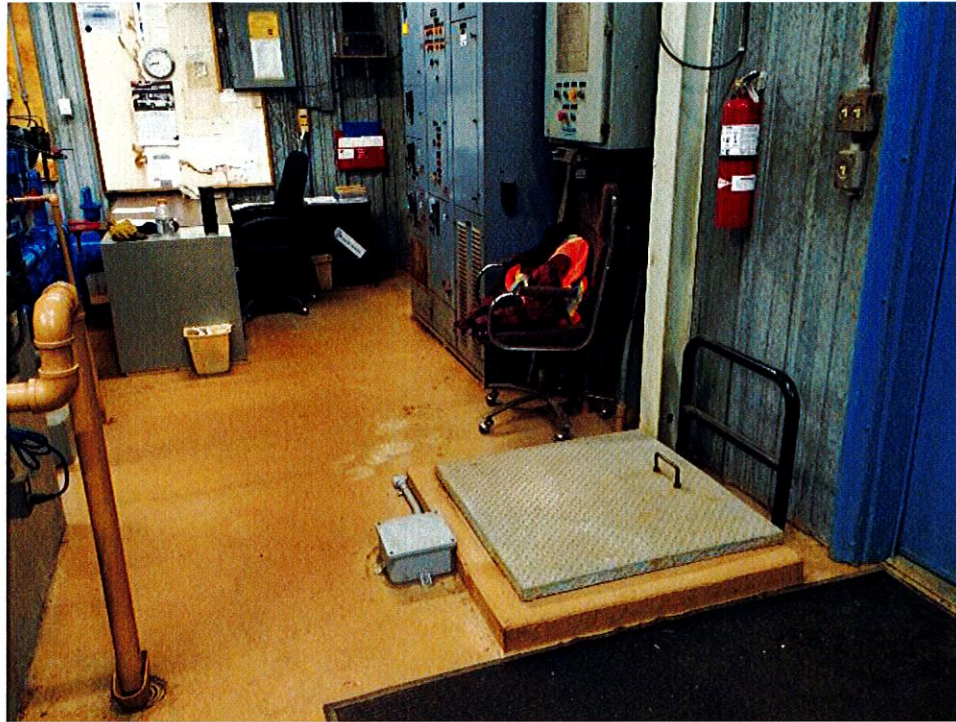
Access to the smaller chamber is through an access hatch located in the water treatment building. The hatch sits on top of 100 mm raised concrete curbing. The exterior access for the larger reservoir chamber is a steel lid on top of a raised concrete curb. This access is always padlocked.

Reservoir Access Hatch
